STATE OF CALIFORNIA
BUSINESS AND TRANSPORTATION AGENCY
DEPARTMENT OF PUBLIC WORKS
DIVISION OF HIGHWAYS

THE EFFECT ON STATE HIGHWAYS
OF
THE SAN FERNANDO EARTHQUAKE
FEBRUARY 9, 1971

SEPTEMBER 1971
SUBMITTED PURSUANT TO SB 682

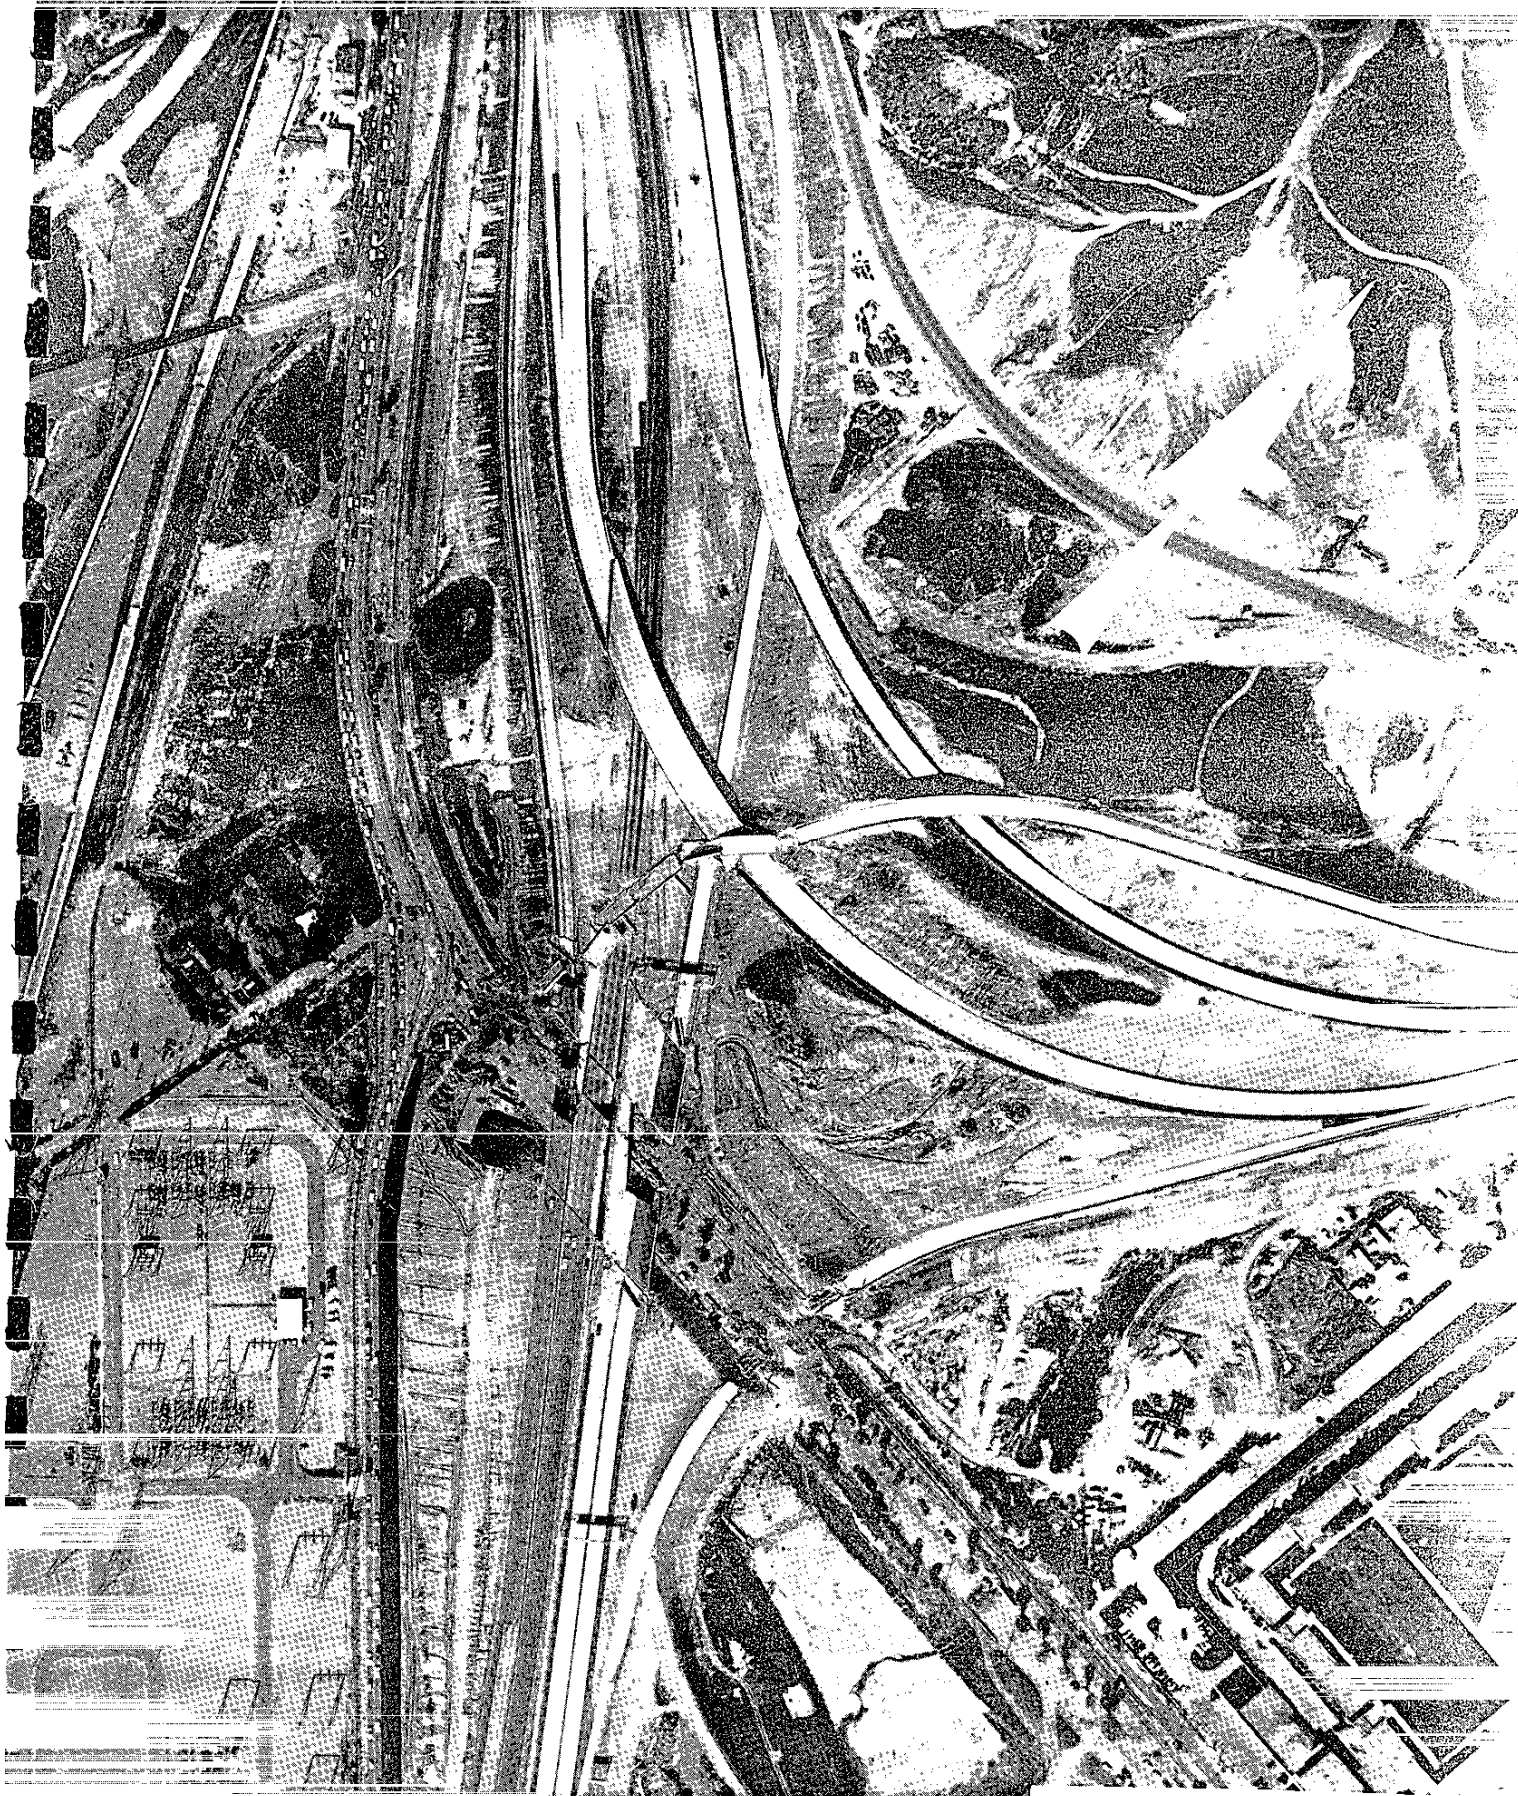
AERIAL VIEW OF
Route 5/210 Interchange
February 11, 1971
(two days after earthquake)

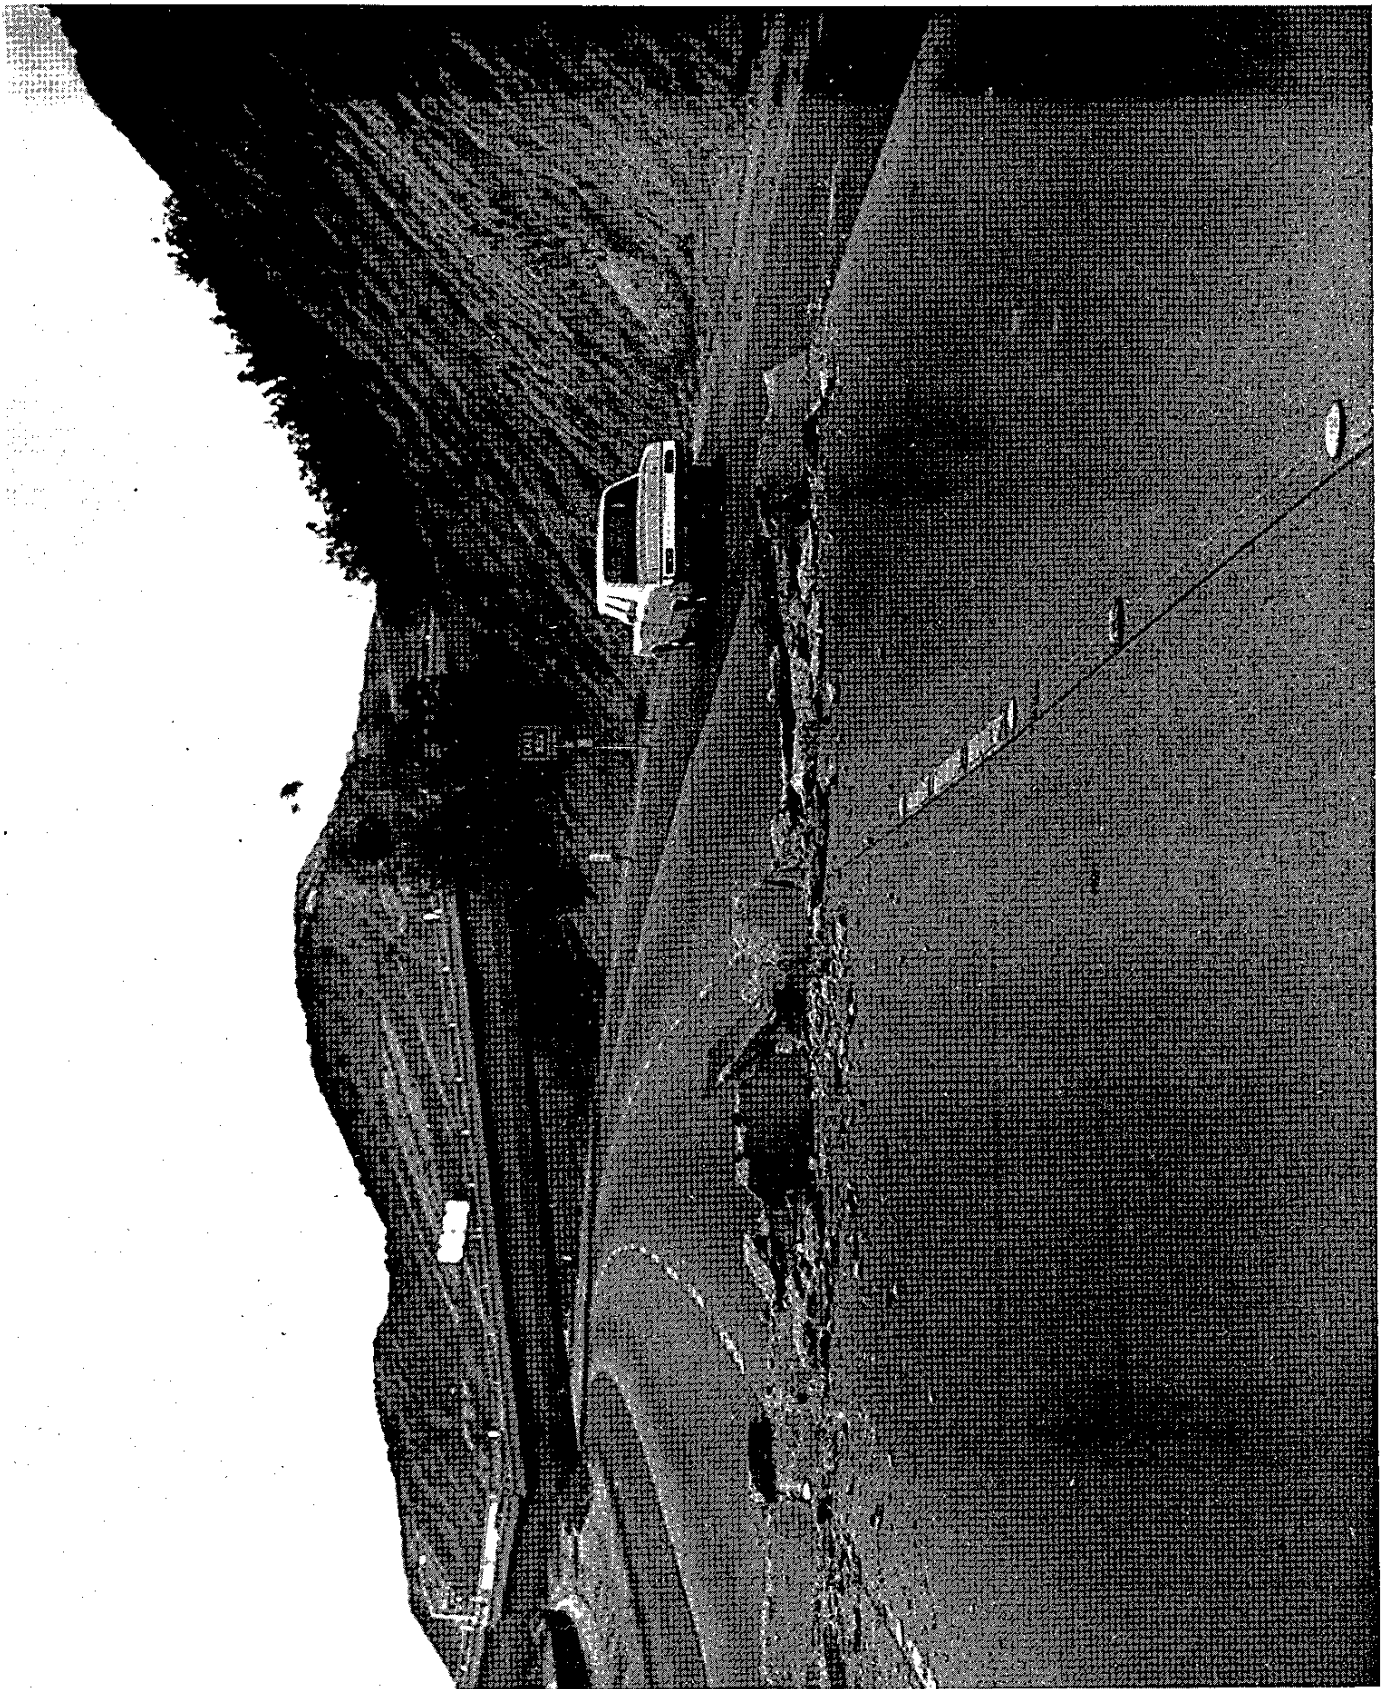
PHOTO 1

ON NB ROUTE 405 AT ROUTE 5

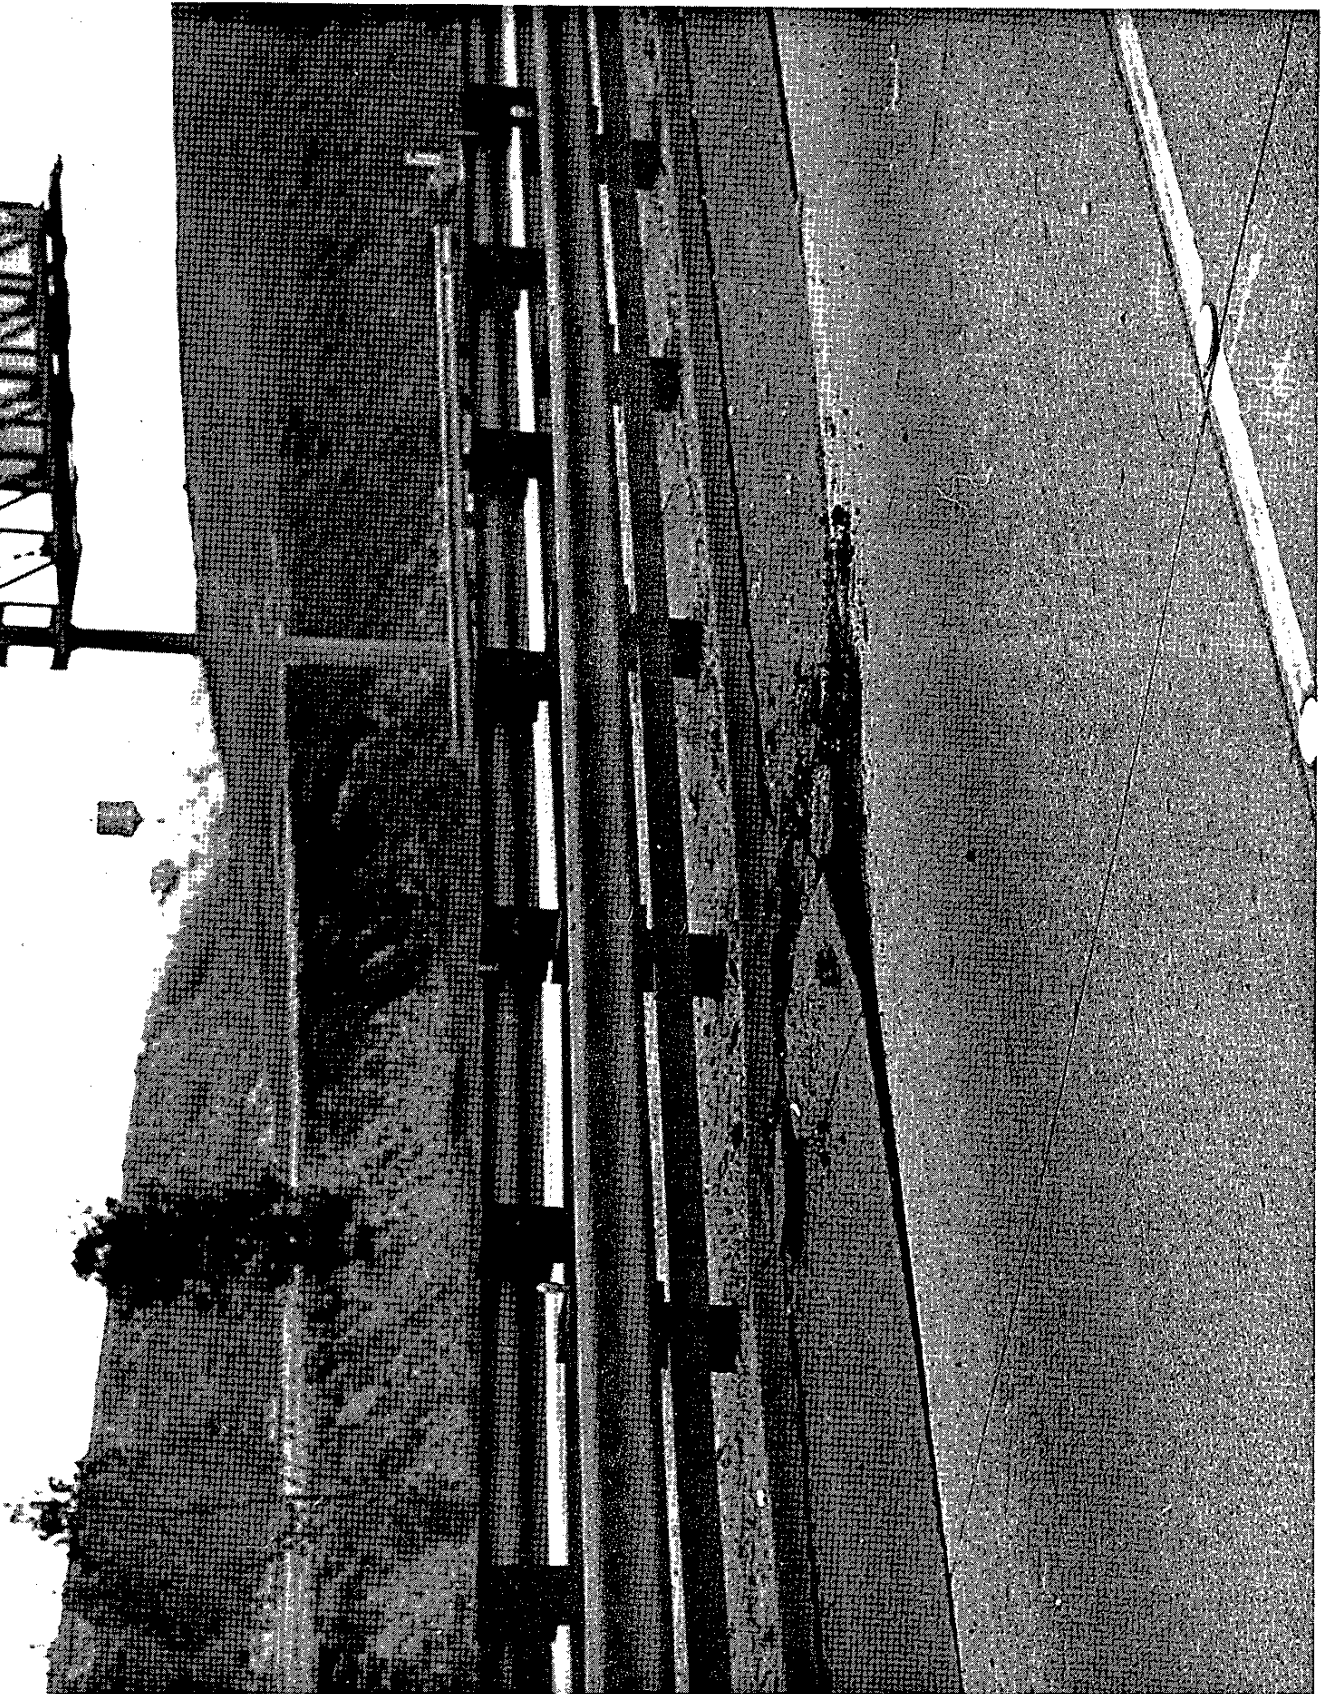
PHOTO 2

ON ROUTE 405 NEAR ROUTE 5

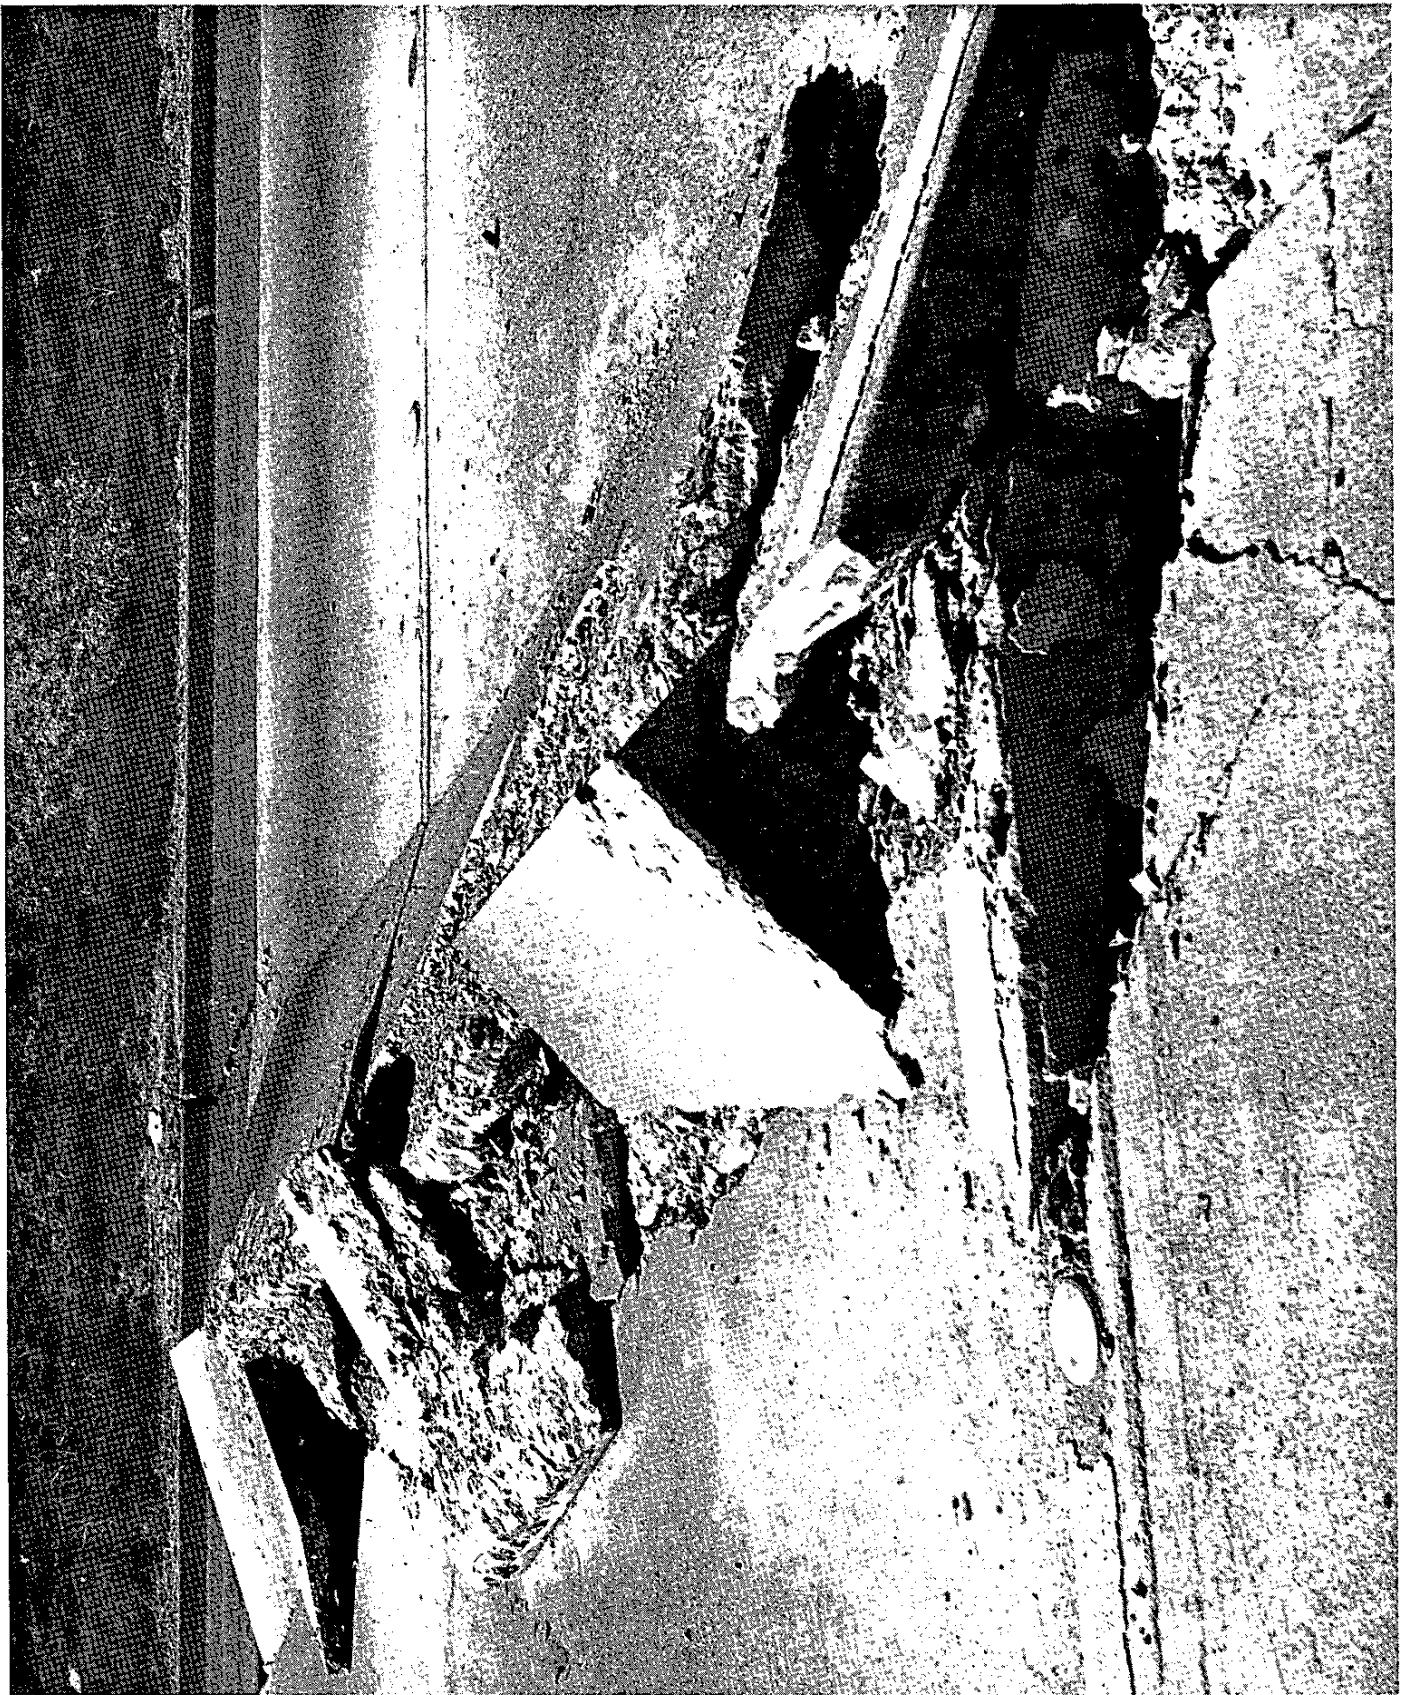
PHOTO 3

ON ROUTE 5 NEAR ROUTE 405

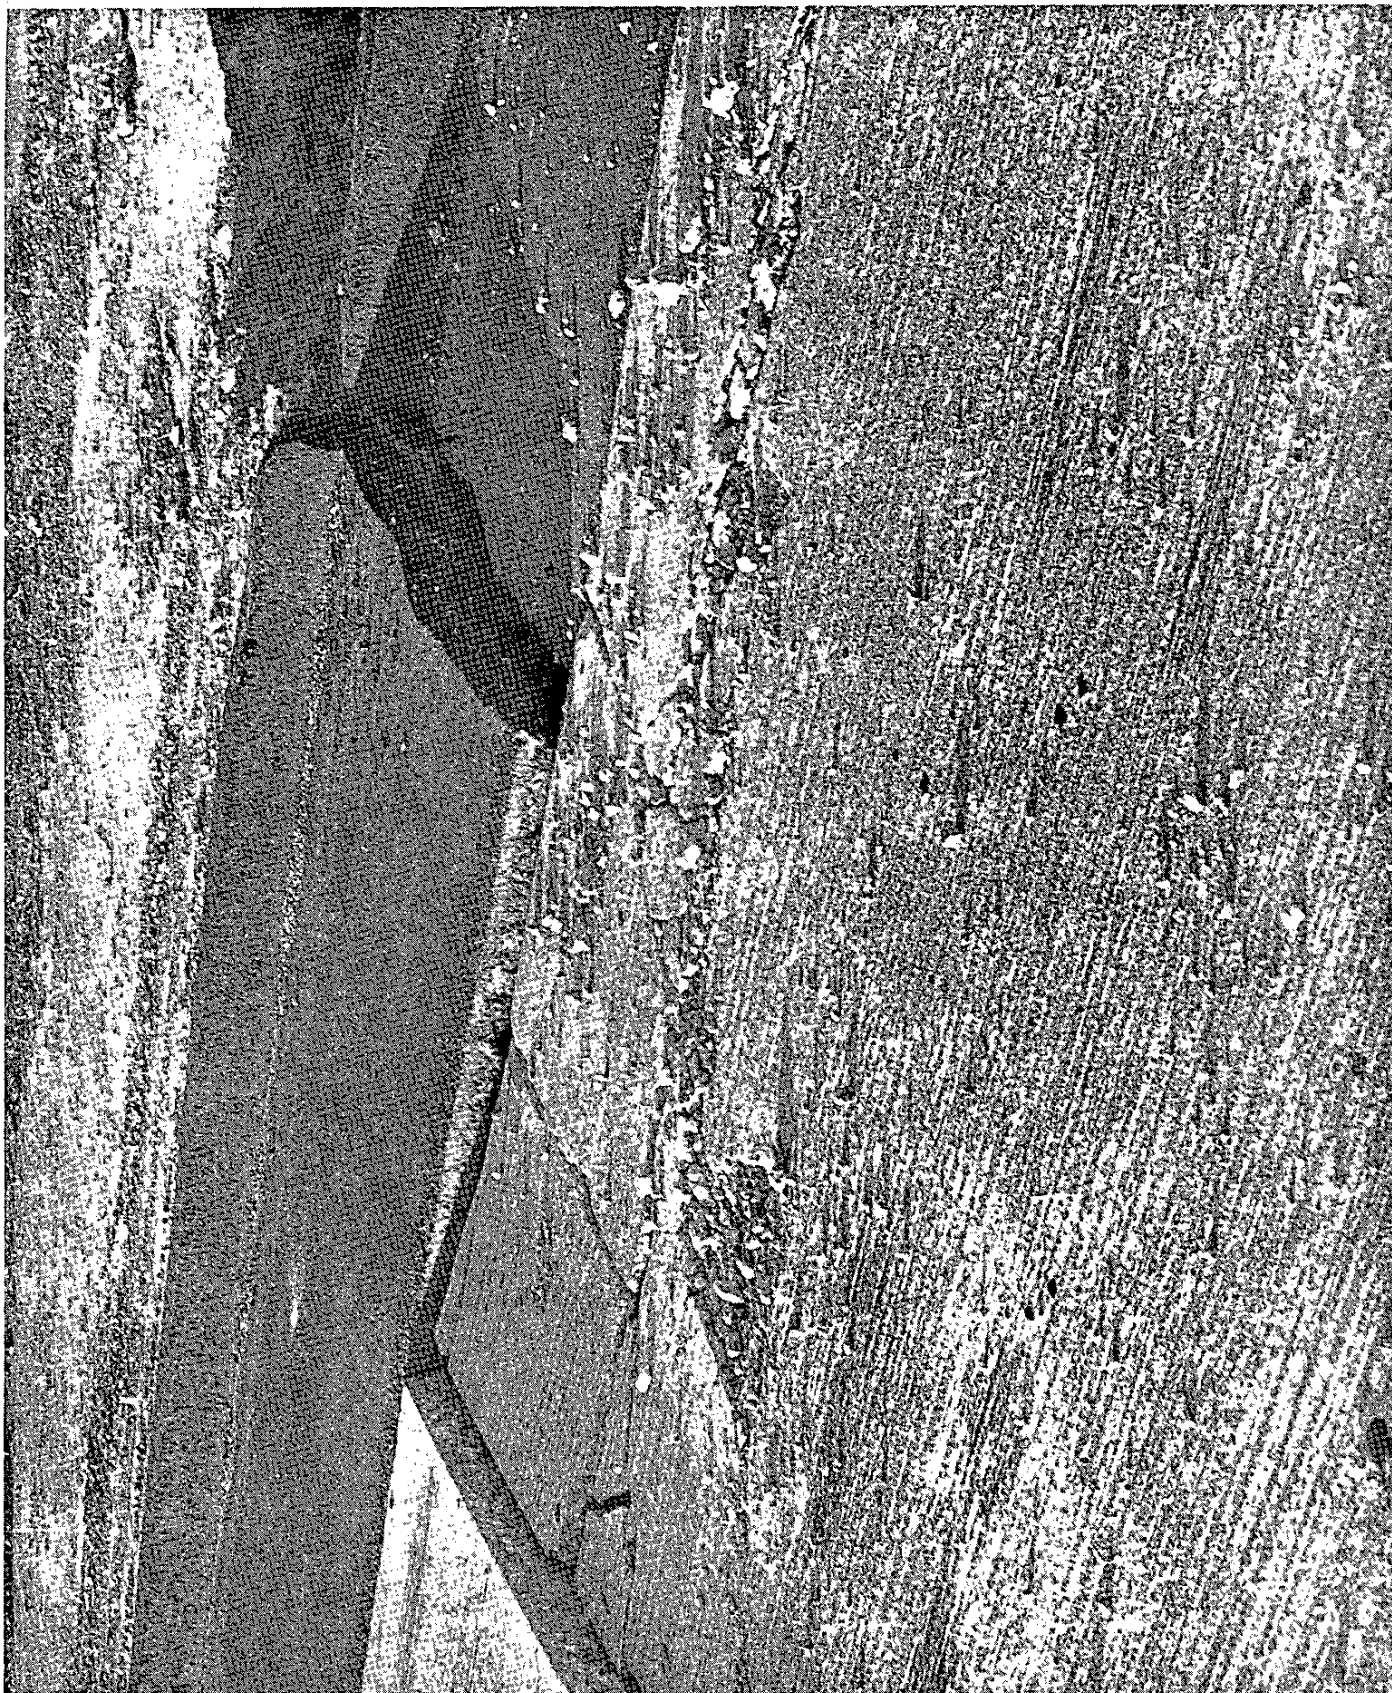
PHOTO 4

ON ROUTE 5 NEAR ROUTE 405

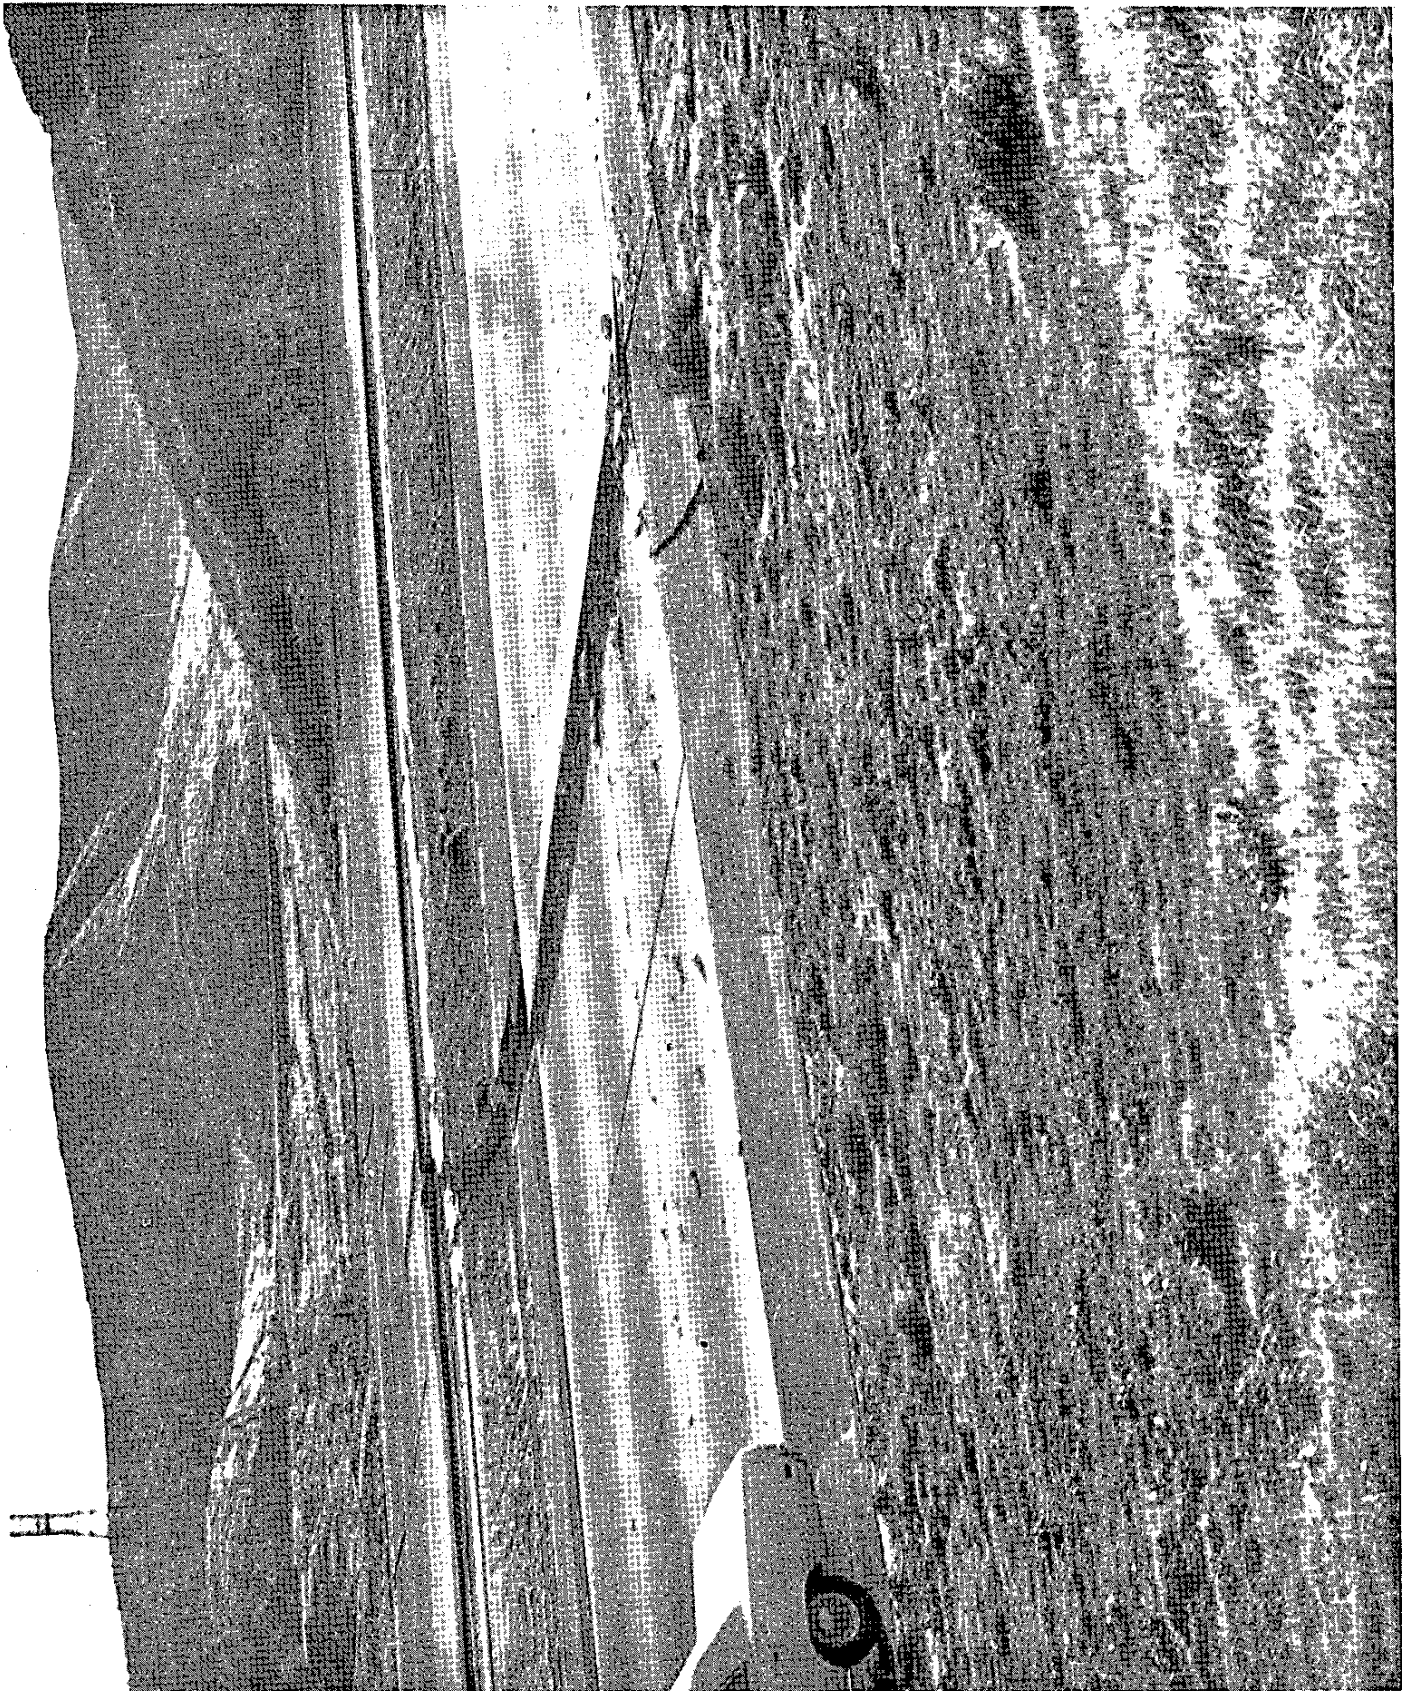
PHOTO 5

ON ROUTE 5 NEAR ROUTE 405

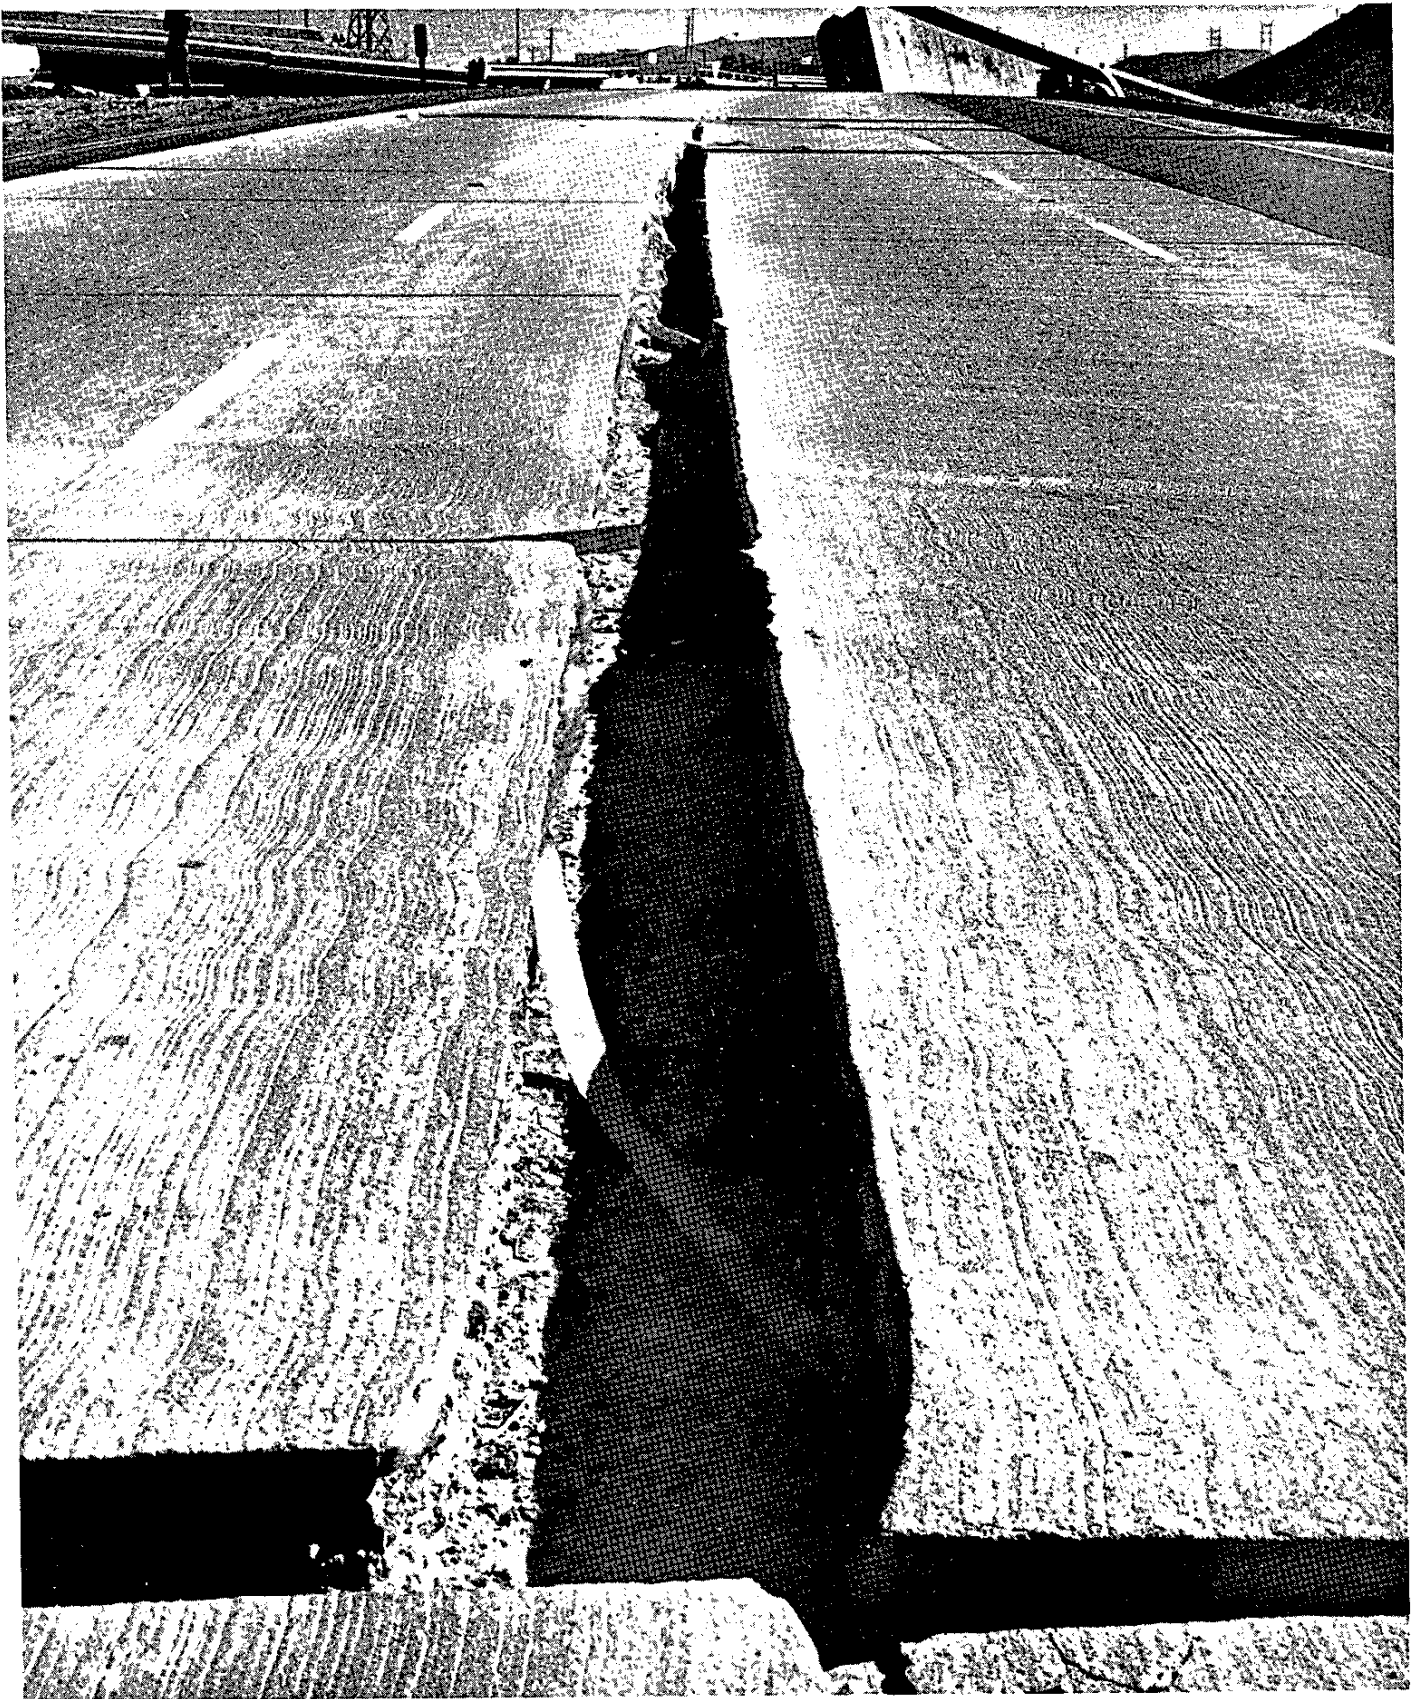
PHOTO 6

ON ROUTE 5 AT ROUTE 210
